THE ACCIDENT ON 26 APRIL 1986.

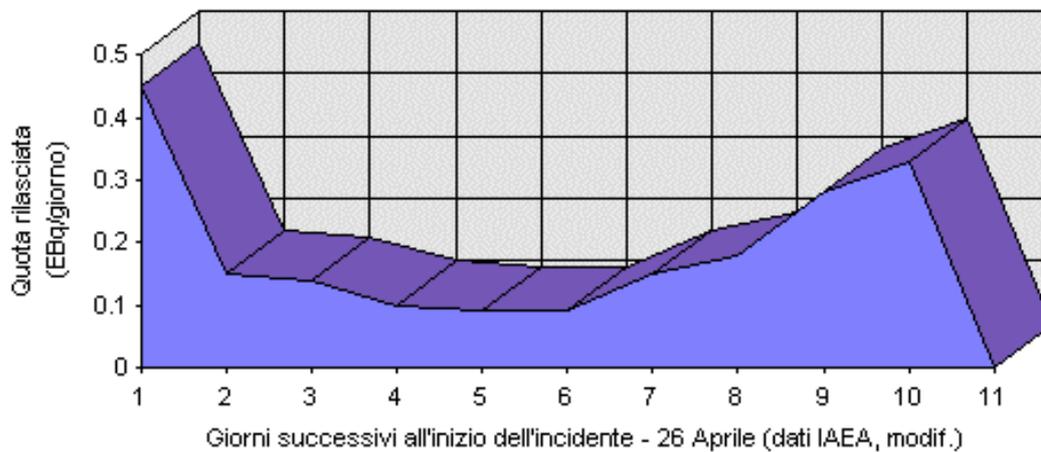
Rilascio giornaliero di radionuclidi nell'atmosfera a seguito dell'incidente al reattore
